NAVAL FACILITIES ENGINEERING SERVICE CENTER
Port Hueneme, California 93043-4370

Technical Report TR-2067-ENV

SURFACE QUALITY IMPACT OF REPLACING VAPOR DEGREASERS WITH AQUEOUS IMMERSION SYSTEMS

March 1997

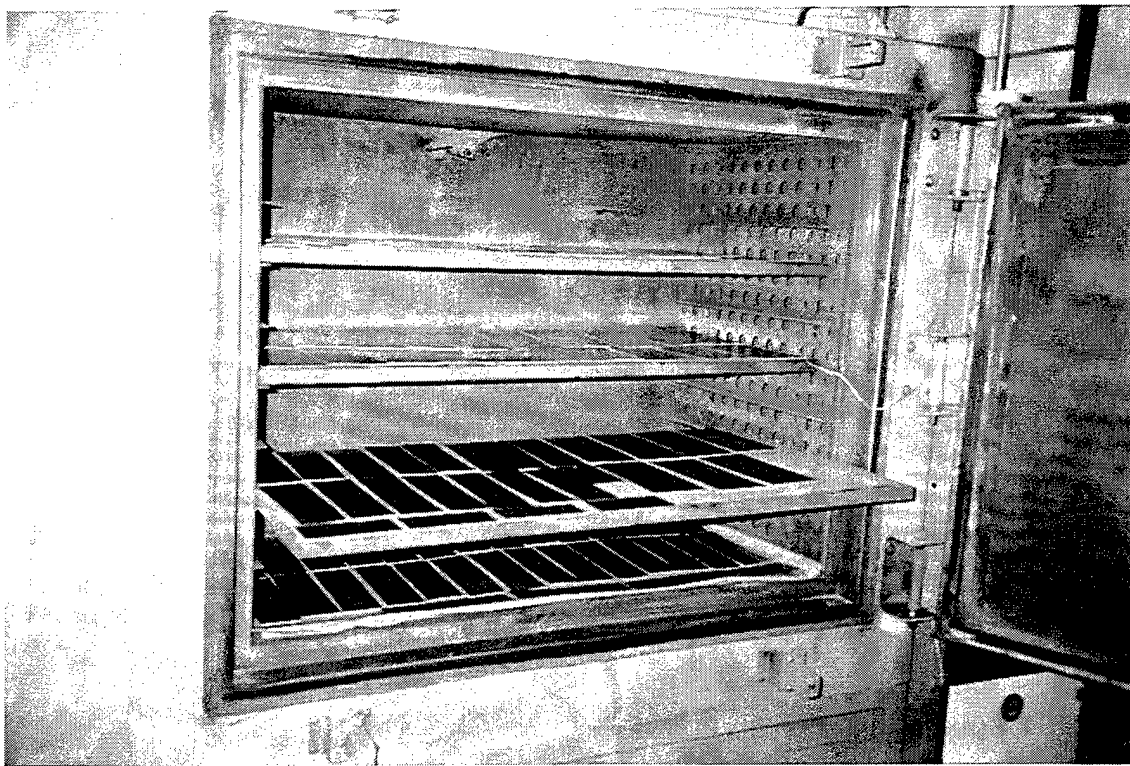
Figure A-3. Panels “weathered” by heating them in a circulating air oven for 2 hours at 150°F.

10. Forming procedures were further simulated by heating all 94 contaminated test panels in a circulating air oven at 150°F for 2 hours. The panels were placed flat on a sheet of clean kraft paper as shown on Figure A-3.

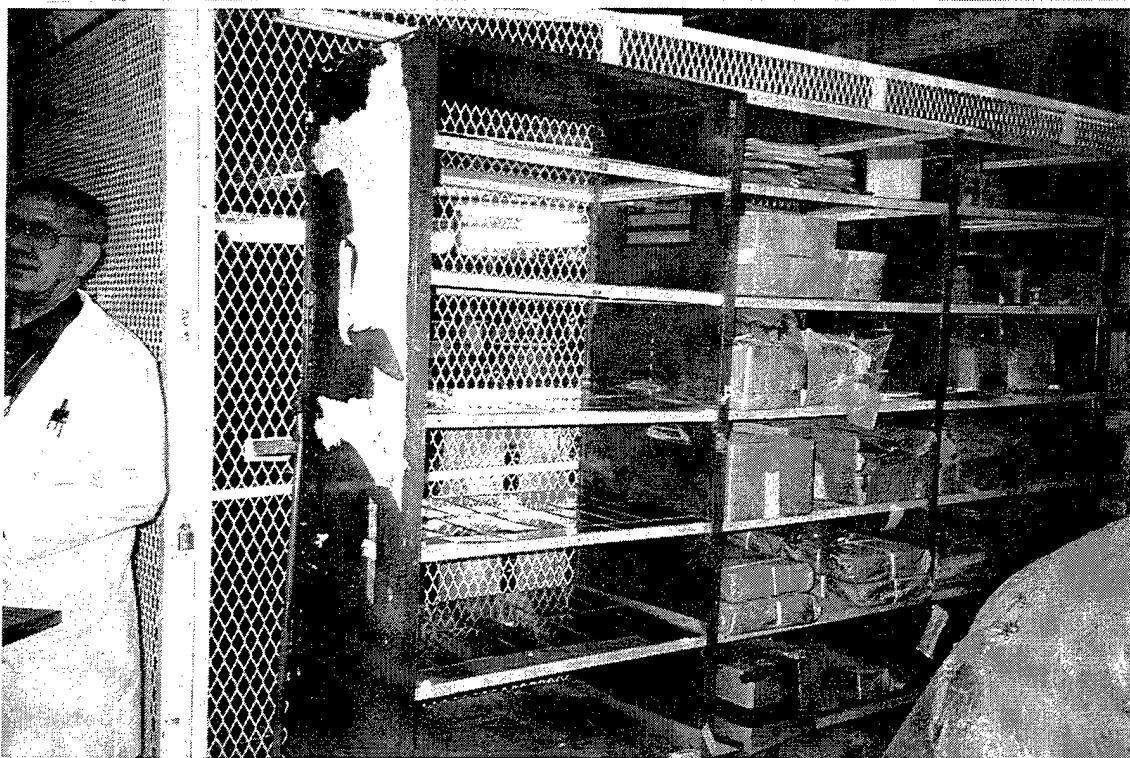
Figure A-4. Soiled panels stored in open shop area for three weeks before degreasing.

11. Finally, all 94 contaminated test panels were stored in a shop environment for 3 weeks, undisturbed but uncovered. Figure A-4 shows the panels stored in the shop area.

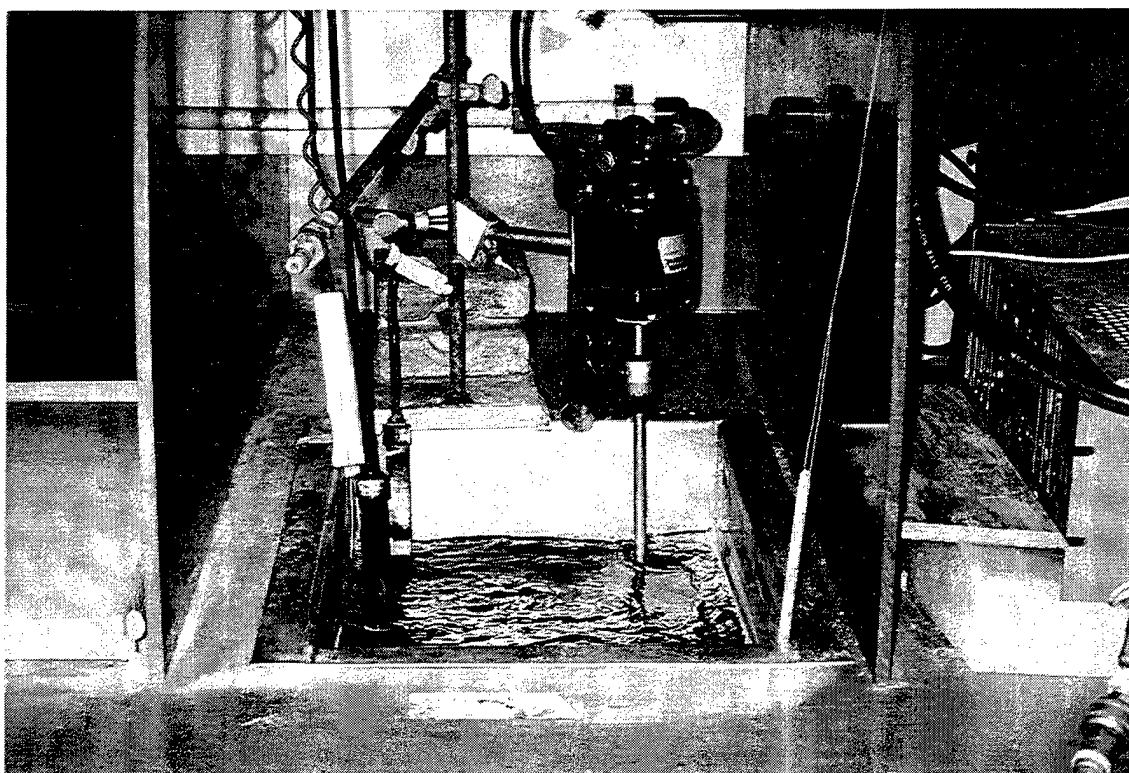
Figure A-5. Laboratory tank used for immersion degreasing with fresh aqueous cleaner.

13. A fresh solution of Brulin 815 GD (15 percent Brulin and 85 percent tap water) was prepared in a laboratory aqueous degreasing tank. Figure A-5 shows the tank used for this part of the tests. This solution was heated to 150°F and agitation set at its maximum value. The agitation is still only moderate as shown on Figure A-6.

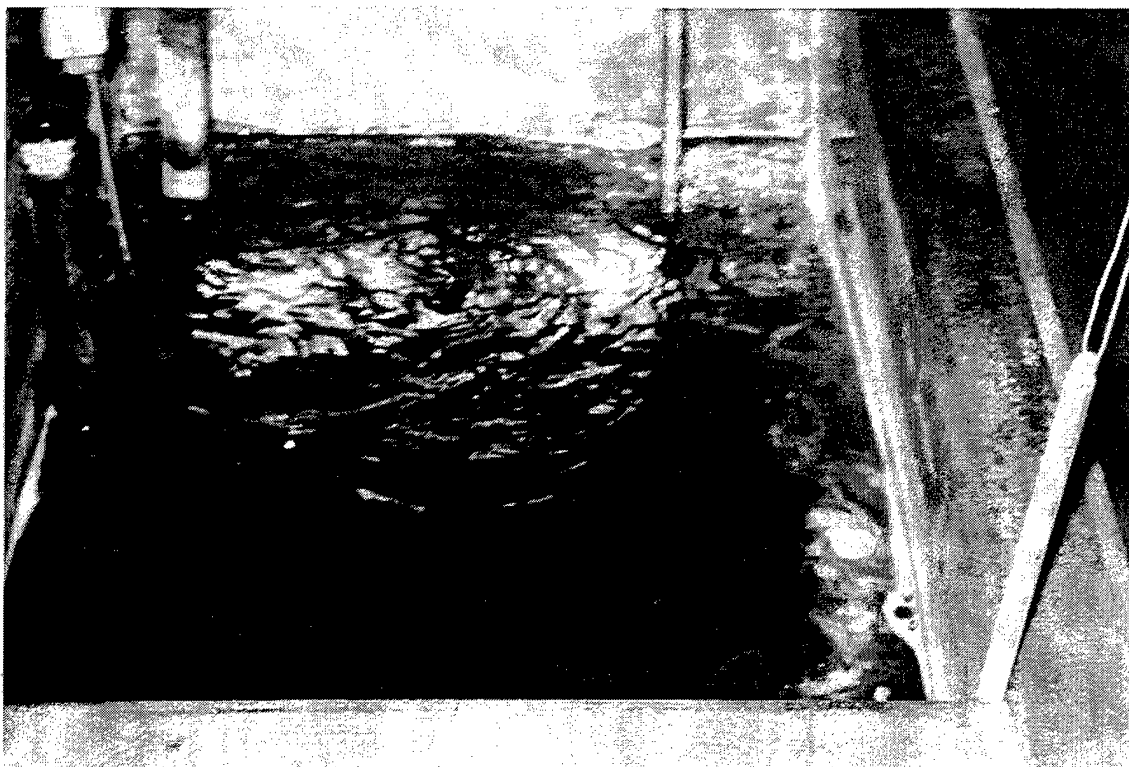
Figure A-6. Agitation of cleaner in laboratory degreasing tank.

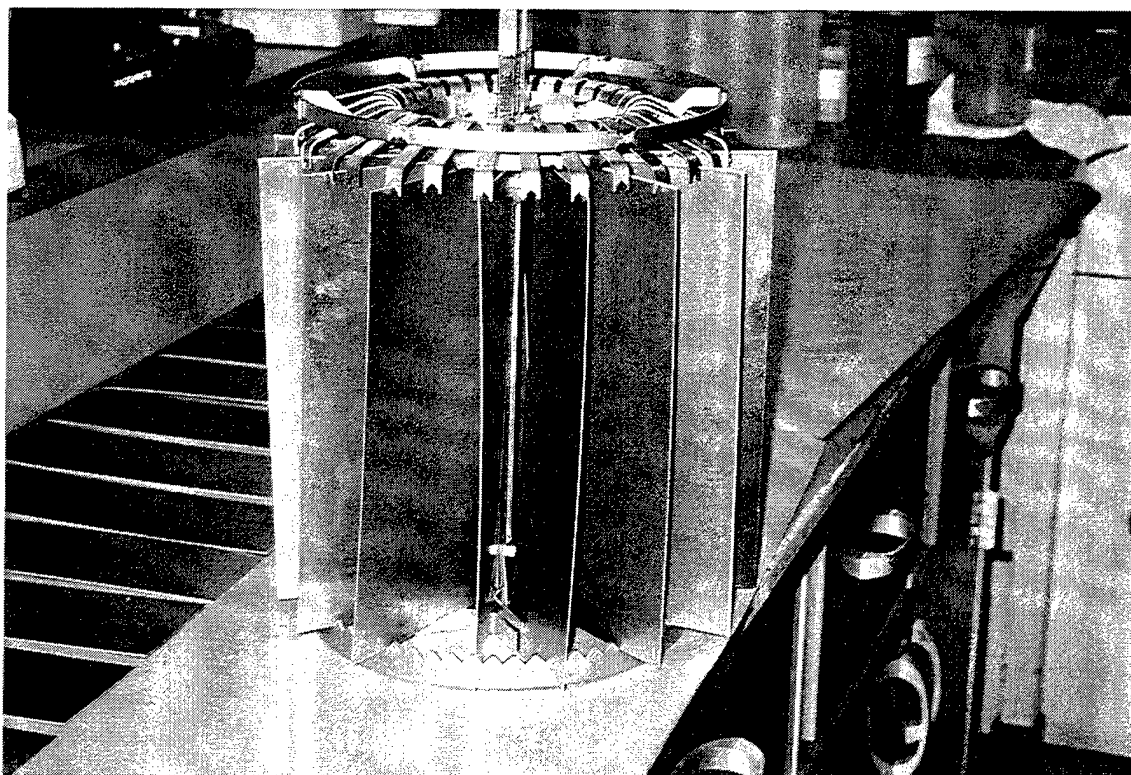
Figure A-7. Panels secured for immersion degreasing in laboratory cleaning tank.

14. Fifteen of the 4.5- by 10-inch test panels, labeled AL1 through AL15, were cleaned for 15 minutes in this laboratory-prepared solution of Brulin 815 GD. Figure A-7 shows the panels secured for immersion in the laboratory-scale aqueous cleaning tank. The panels were rinsed for 2 minutes in a tap water tank and inspected for cleanliness, using the water break free test. All panels passed this test. The panels were dried, wrapped in clean dry kraft paper, and delivered for anodizing.

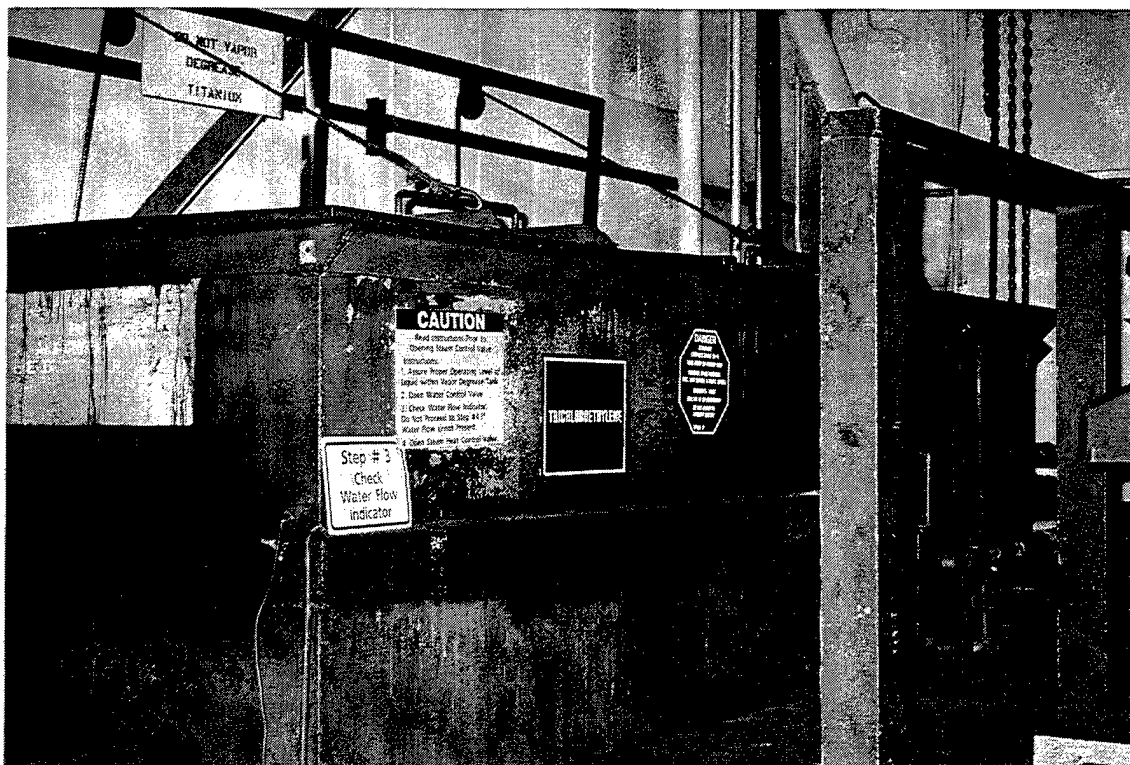
Figure A-8. External view of TCE vapor degreaser.

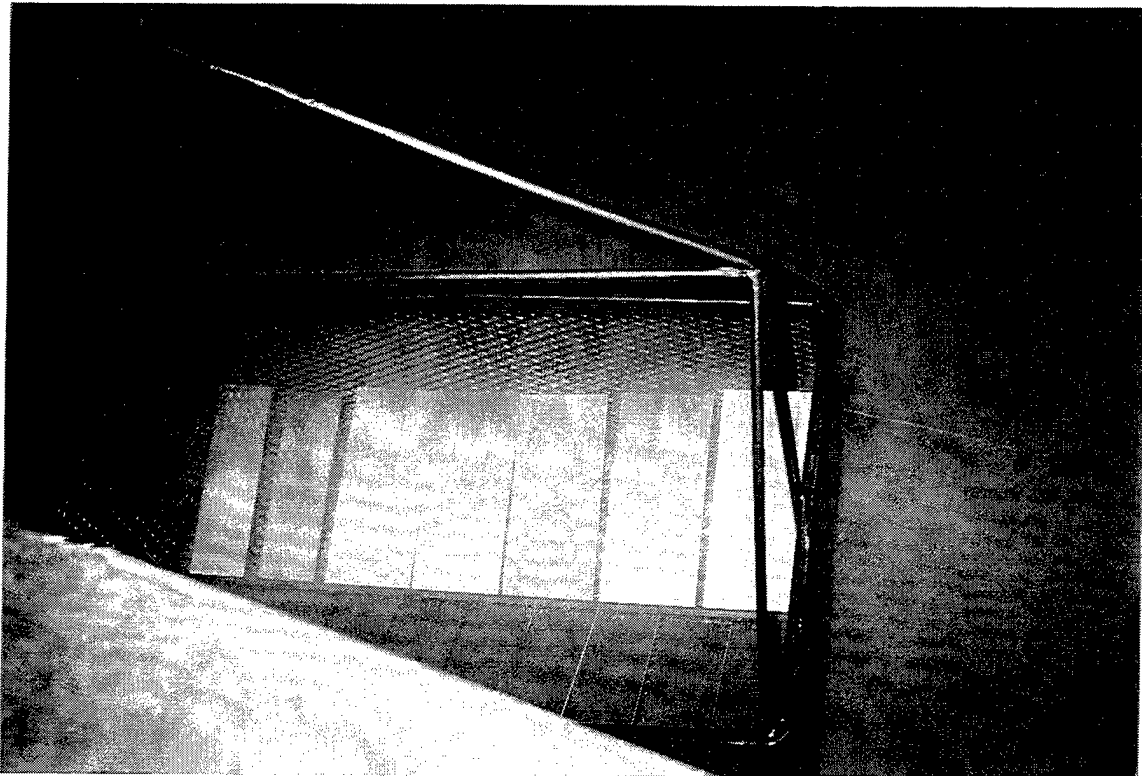
Figure A-9. Panels are immersed in TCE vapor.

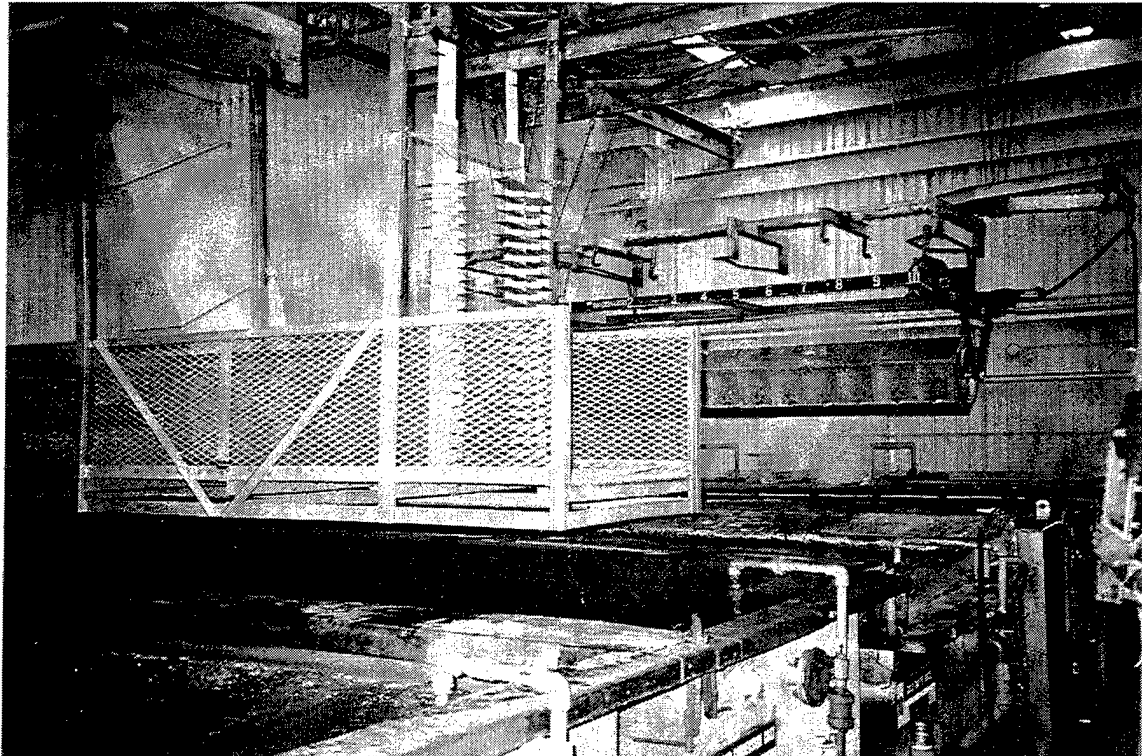
Figure A-10. Racked panels are lowered into industrial-sized tank for immersion aqueous degreasing.

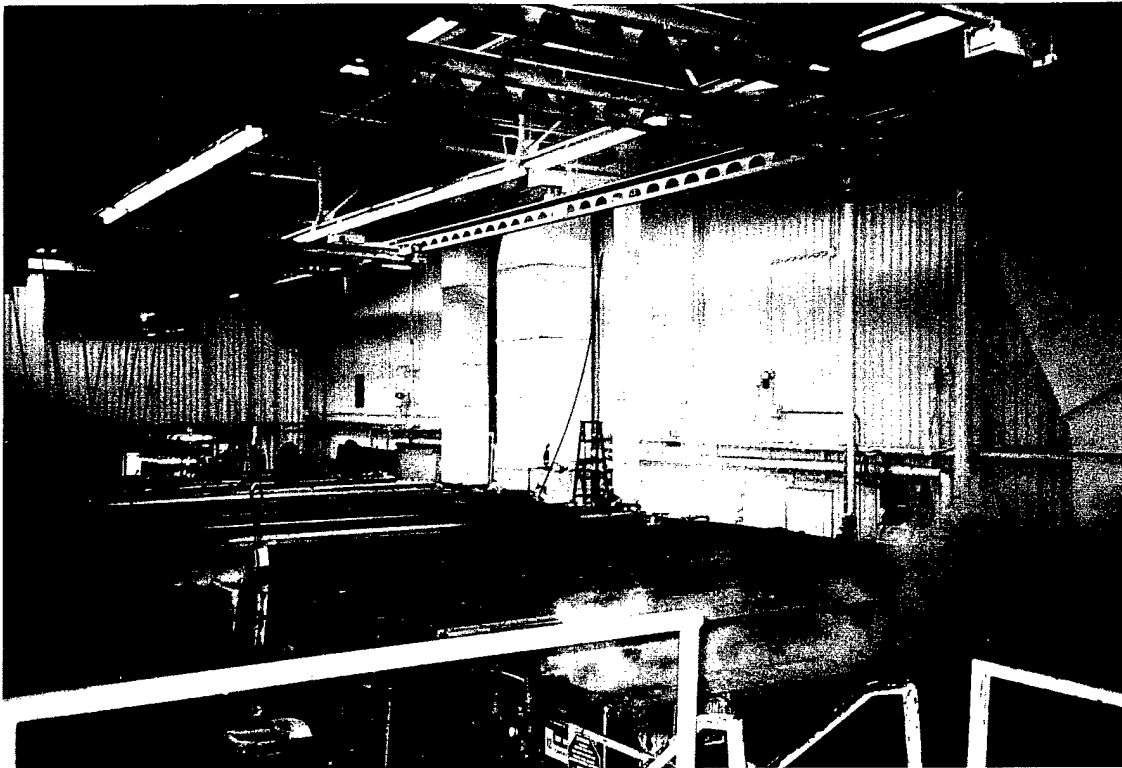
Figure A-11. Cleaning, deoxidizing, rinsing, and anodizing tanks arranged in order.

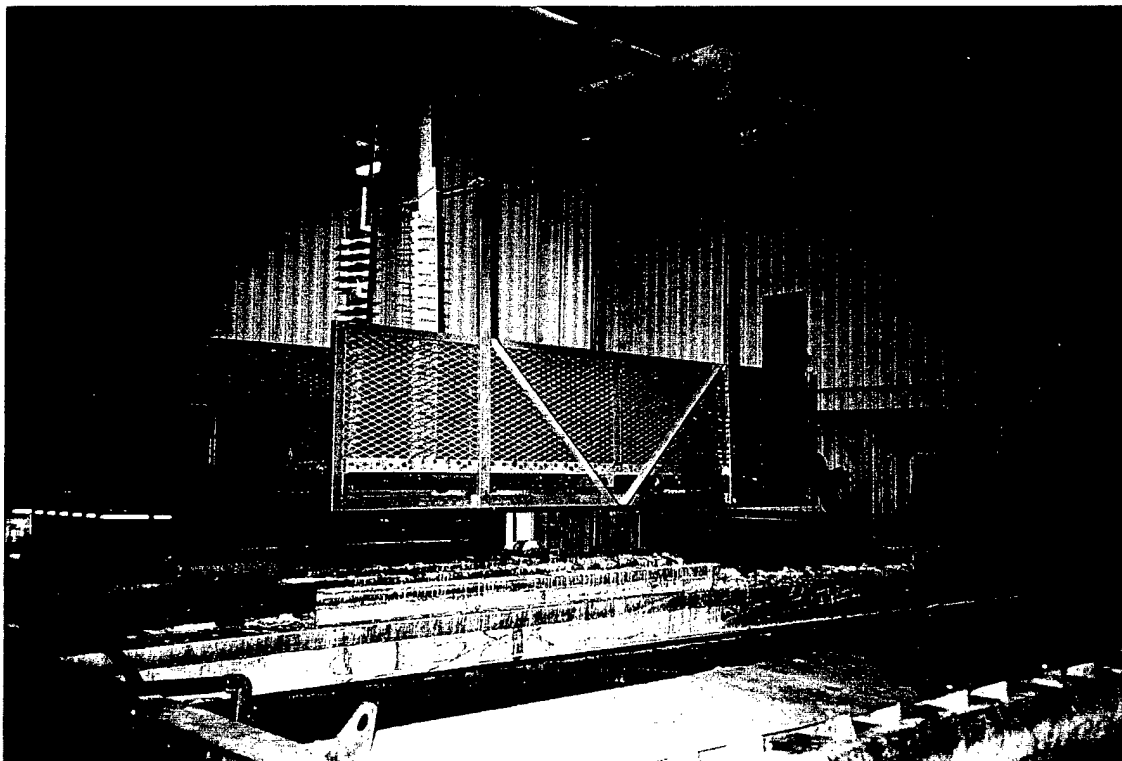
Figure A-12. Rack containing the panels to be anodized was simply moved from tank to tank.

23. The thirty 4.5- by 10-inch test panels to be anodized, AL1 through AL10, AS1 through AS10, and VS1 through VS10, and the thirty 3- by 10-inch test panels to be conversion coated, also designated AL1 through AL10, AS1 through AS10, and VS1 through VS10, were prepared for finishing by first immersing them in a 5 percent solution of the alkaline cleaner Turco 4215 NC-LT for 10 minutes. The existing surface oxides were then removed by pickling in a 50 percent nitric acid solution for 4-1/2 minutes (9-1/2 minutes for the panels to be anodized) and in a dilute solution of the deoxidizer Amchem 7/17 for another 3 minutes. The panels were rinsed in ordinary tap water after each step. The process tanks were arranged in order (Figure A-11) and the rack containing the panels was simply moved from tank to tank (Figure A-12).

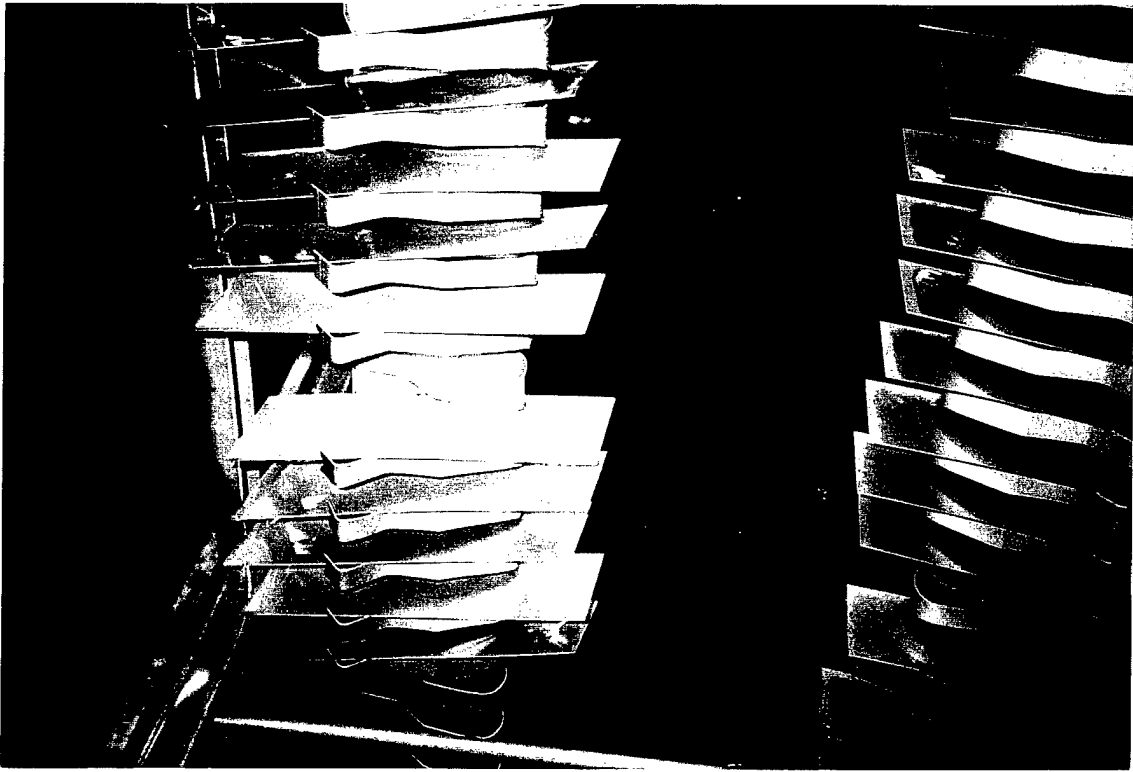
Figure A-13. Conversion-coated panels immediately after removal from the reagent tank.

26. The thirty 3- by 10-inch test panels labeled AL1 through AL10, AS1 through AS10, and VS1 through VS10 were chemically conversion coated, immersing the panels in a 1 percent solution of the reagent Iridite 14-2 for 3 minutes, meeting the requirements specified in MIL-C-5541. Figure A-13 shows the conversion-coated panels immediately after removal from the reagent tank.

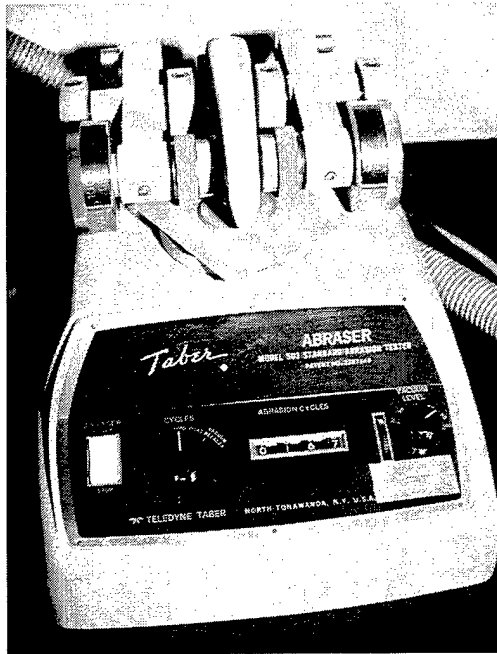
Figure C-1. Aluminum panel being tested in the abraser.

Abrasion resistance was evaluated in accordance with Method 6192.1 of FED-STD-141C which is specified by MIL-A-8625F: Anodic Coatings, for Aluminum and Aluminum Alloys. A Model 503 Taber abraser was employed. Rubbing wear is produced by the abraser by rotating the sample on a vertical axis while in contact with two weighted abrasive wheels as shown on Figure C-1.

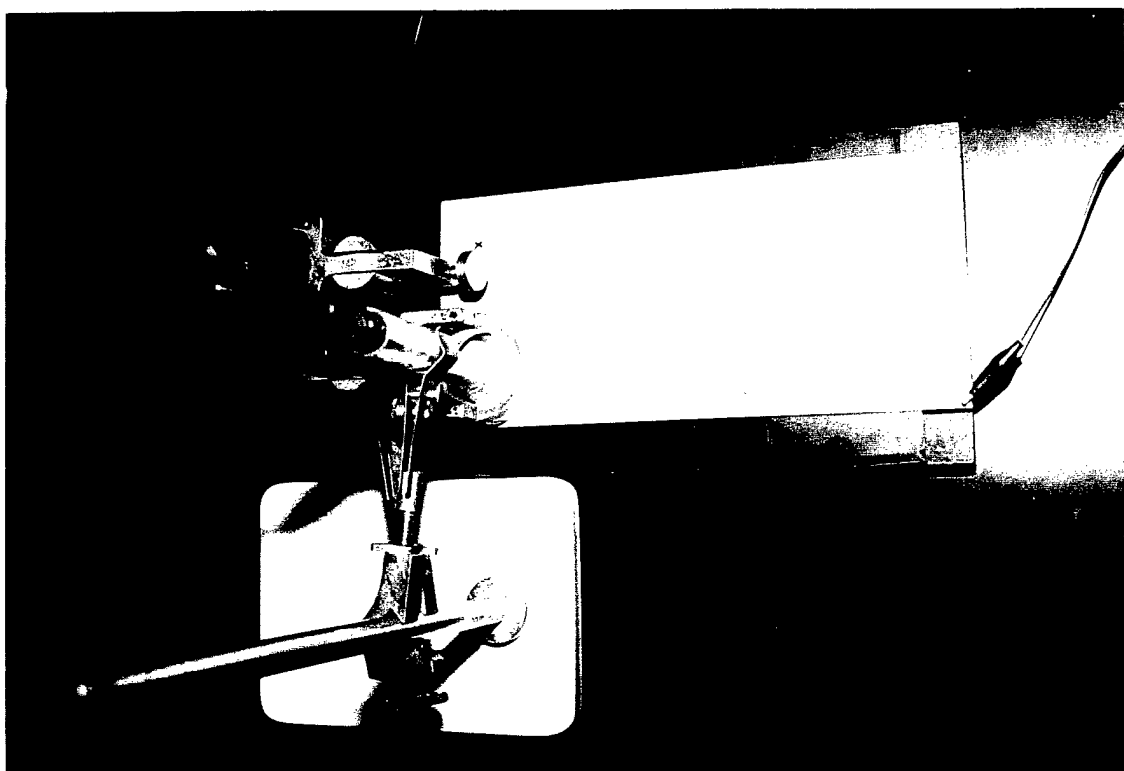
Figure C-3. Cathodic breakdown test fixture.

The test apparatus shown in Figure C-3 was employed for containment of the electrolyte. A Plexiglas cylinder with an "O"-ring seal on the lower rim was clamped to the surface. The sealed area was then submerged in electrolyte consisting of 10 mL of a 5 percent solution of sodium chloride. The area of the submerged surface was 11.40 cm².

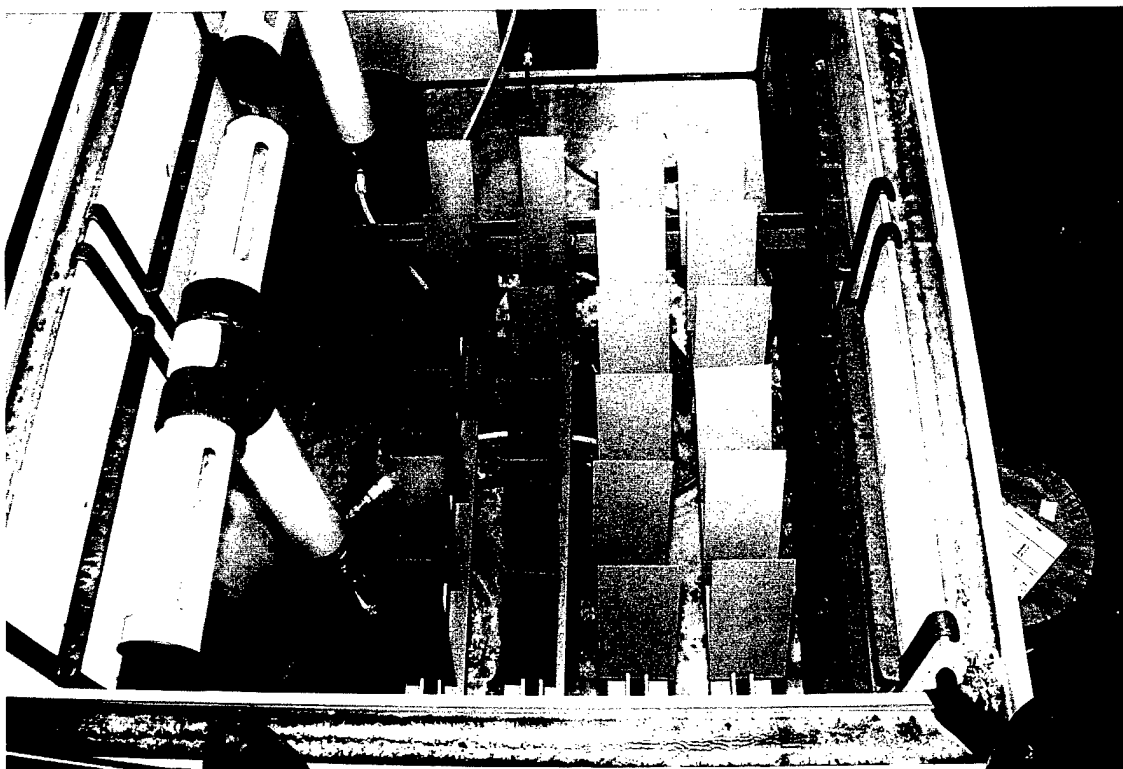
Figure C-4. Salt fog chamber with test panels inside.

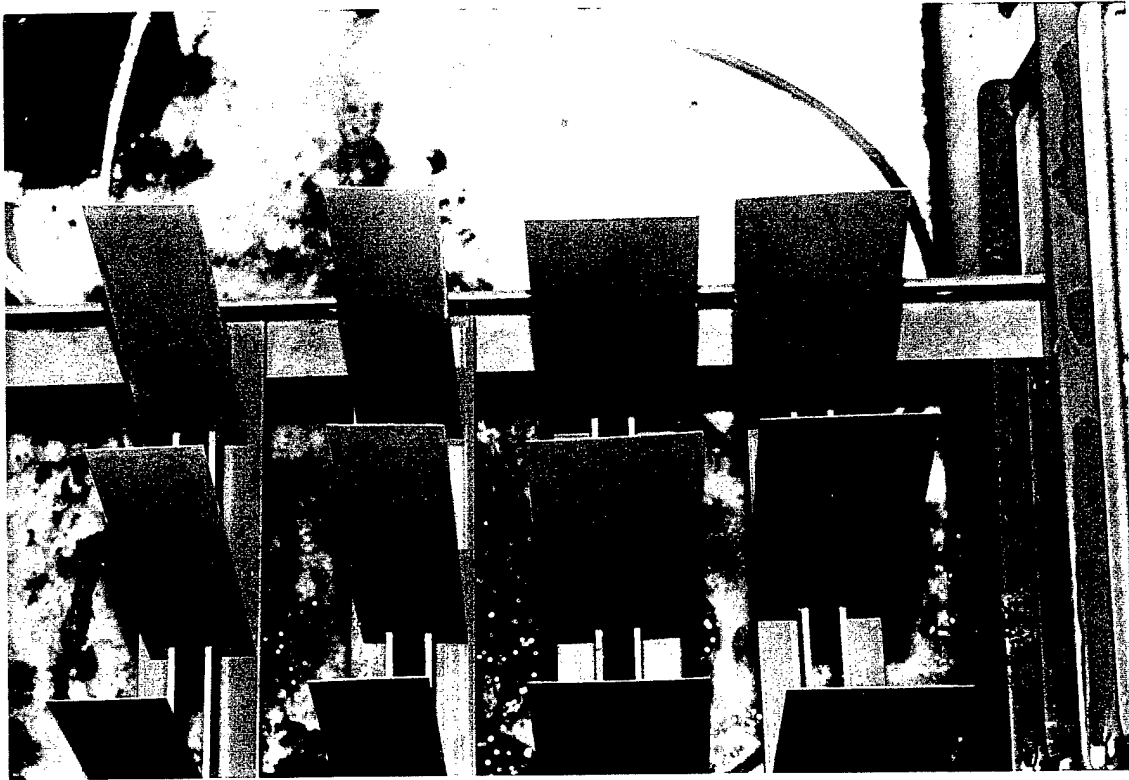
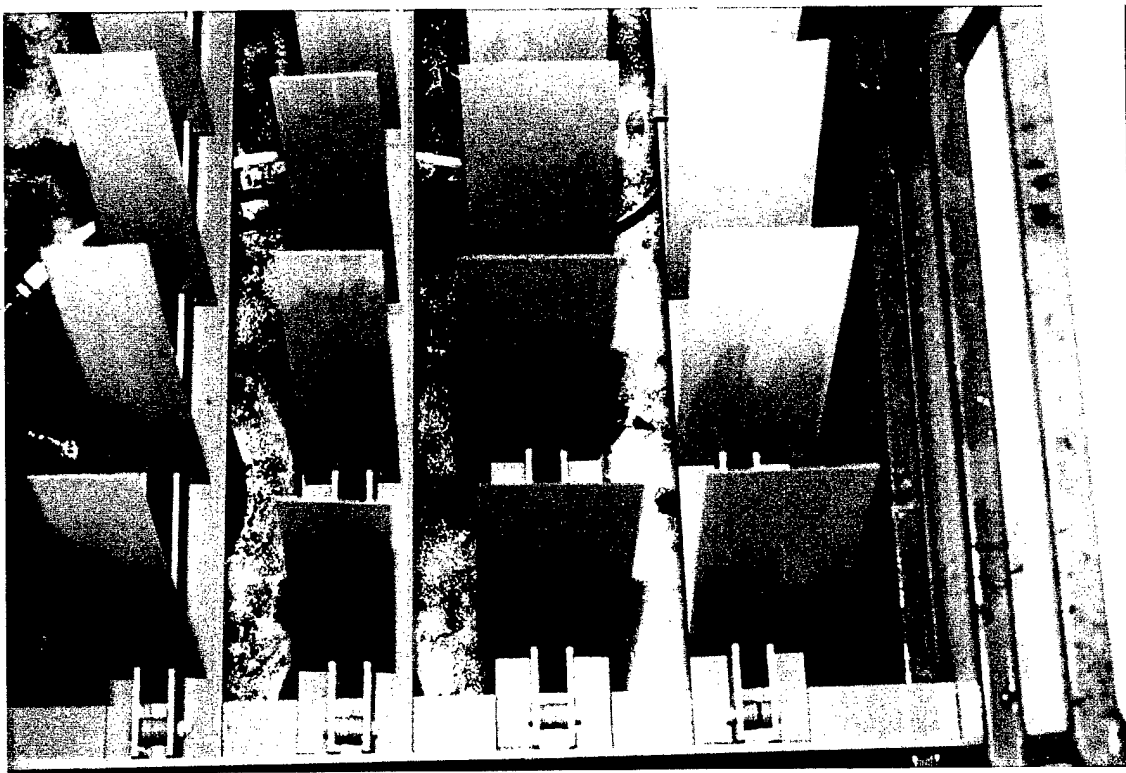
Figure C-5. Conversion-coated (on the left) and anodized panels after 2 weeks of exposure to salt fog.

Figure C-5 is a photograph taken at 2 weeks (336 hours) of exposure. After this exposure period, which is specified by MIL-A-8625, no corrosion other than that associated with defects due to anodizing electrode contact, scratches, or edge effects was observed on any of the conversion-coated or anodized panels. Testing was continued to determine if longer-term exposure might reveal differences in performance. Figures C-6 and C-7 are photographs of the panels taken at 3 and 4 weeks of exposure, respectively. After 4 weeks of exposure, all panels including the conversion-coated panels exhibited no more than a single pit which could not be tied to original defects. However, the conversion-coated panels did experience corrosion at the panel identification stamps which was not observed on the anodized panels. These cracks were observed on all the conversion-coated panels. No difference could be established between panels subjected to the different cleaning processes.

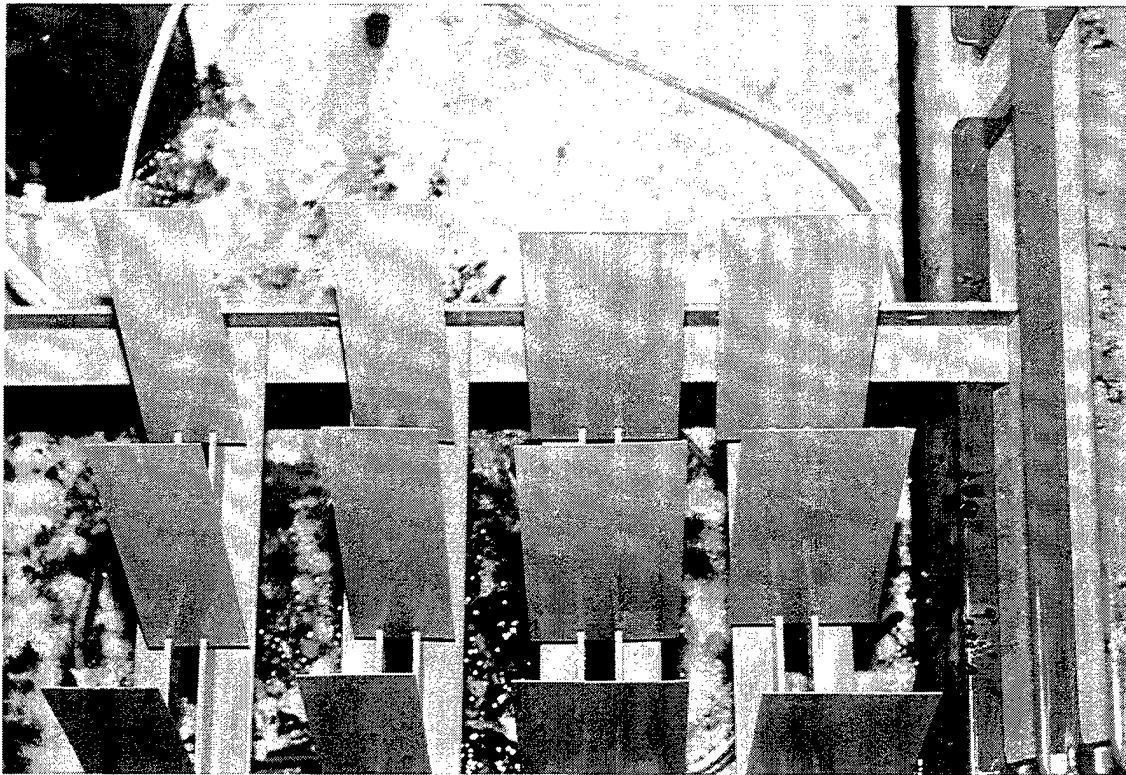
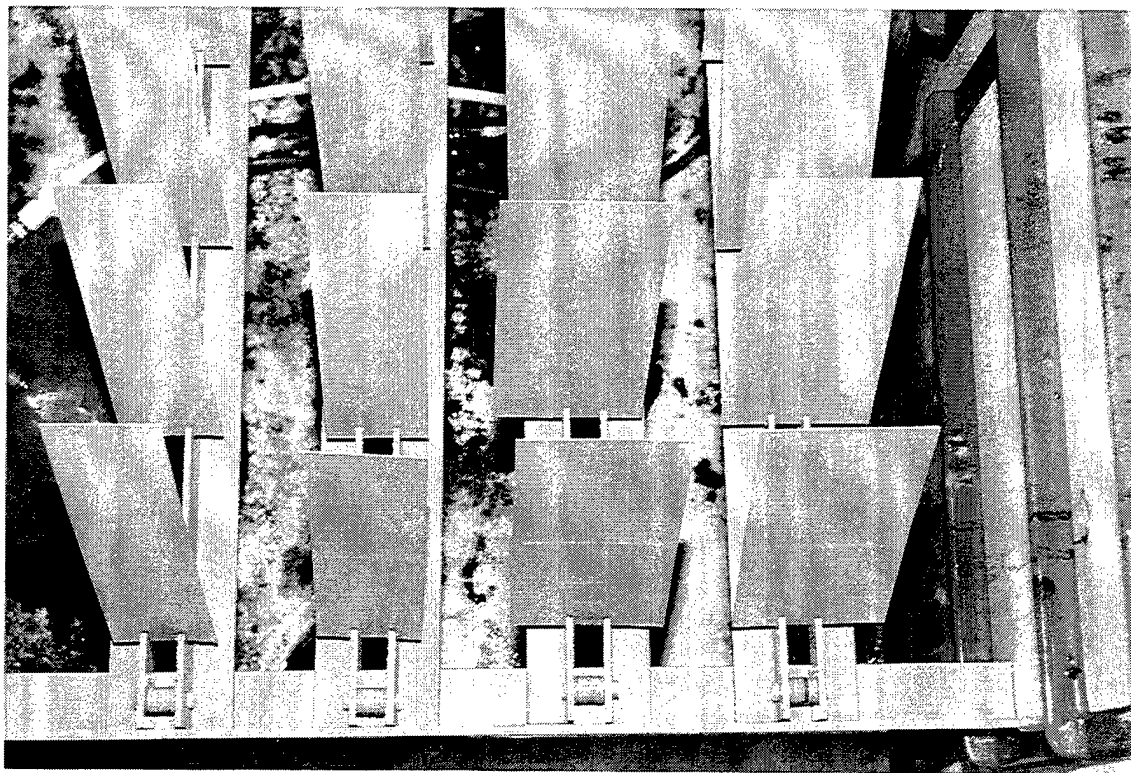
Figure C-6. Conversion-coated and anodized panels after 3 weeks of exposure to salt fog.

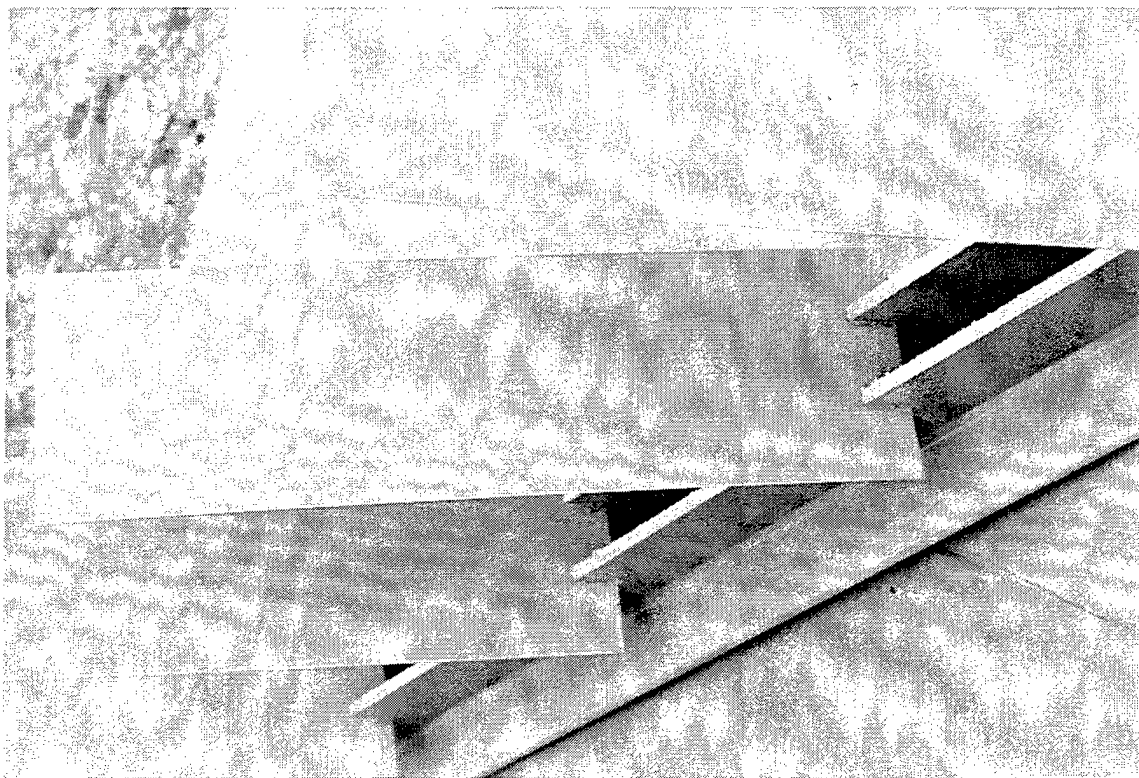
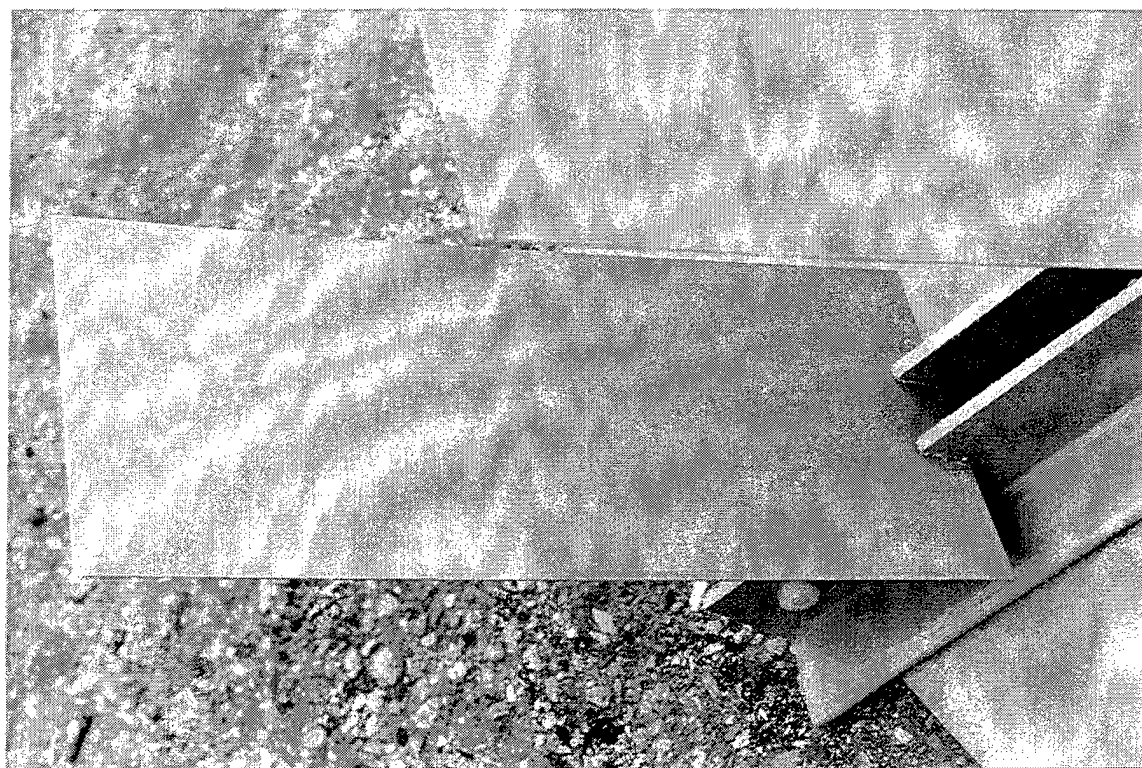
Figure C-7. Conversion-coated (top) and anodized panels after 4 weeks of exposure to salt fog.
